DEPARTMENT OF TRANSPORTATION

Quality Assurance and Source Inspection

Contract #: 04-0120F4Cty: SF/ALA Rte: 80 PM: 13.2/13.9File #: 1.28**WELDING INSPECTION REPORT****Resident Engineer:** Casey, William**Address:** 333 Burma Road**City:** Oakland, CA 94607**Report No:** WIR-026829**Date Inspected:** 07-Dec-2011**Project Name:** SAS Superstructure**OSM Arrival Time:** 700**Prime Contractor:** American Bridge/Fluor Enterprises, a JV**OSM Departure Time:** 1730**Contractor:** American Bridge/Fluor Enterprises, a JV**Location:** Job Site**CWI Name:** Fred Von Hoff**CWI Present:** Yes No**Inspected CWI report:** Yes No N/A**Rod Oven in Use:** Yes No N/A**Electrode to specification:** Yes No N/A**Weld Procedures Followed:** Yes No N/A**Qualified Welders:** Yes No N/A**Verified Joint Fit-up:** Yes No N/A**Approved Drawings:** Yes No N/A**Approved WPS:** Yes No N/A**Delayed / Cancelled:** Yes No N/A**Bridge No:** 34-0006**Component:** OBG Sections**Summary of Items Observed:**

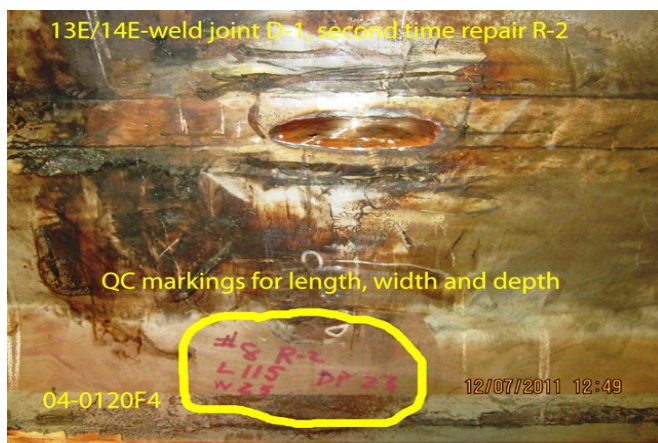
(#9677) performing Shielded Metal Arc Welding (SMAW) at a repair excavation located at Y-1600. QC Inspector Fred Von Hoff informed this QA Inspector the excavation was 140 mm long, 30 mm wide and 11 mm deep. This QA Inspector observed QC Inspector Fred Von Hoff verify the following welding parameters; 135 amperes. This QA Inspector observed the Post Weld Heat Treatment (PWHT) started at approximately 0845 hours this shift and was informed by QC Inspector Fred Von Hoff the PWHT would be held for 1-hour. The work observed by this QA Inspector appeared to comply with Welding Procedure Specification (WPS) ABF-WPS-D15-1004 Repair.

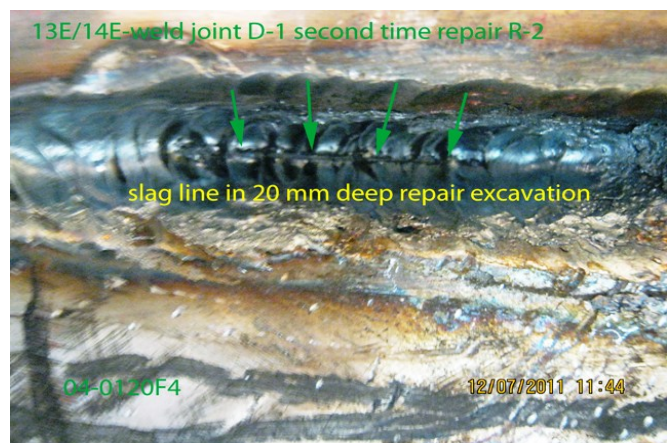
At Y-6170 this QA Inspector observed QC Inspector John Pagliero performing Ultrasonic Testing (UT) and was informed that this repair area (Y-6170) was rejected again. This QA Inspector was informed by ABF welding Foreman James Zhen (#6001) the excavation would be performed from outside the OBG section (Face B). This QA Inspector was aware the first time repair had been performed from this same face and confirmed this with QC Inspectors John Pagliero and Fred Von Hoff. This QA Inspector observed ABF welding personnel Wai Kitlai (#2953) preheat the repair area with a hand held gas torch prior to using the carbon arc process to excavate the repair (R-2) area. ABF welding personnel Wai Kitlai (#2953) stopped at a depth of approximately 18 mm and informed QC Inspectors John Pagliero and Fred Von Hoff and this QA Inspector he had found the defect; a slag line. See photo below of the excavation with the slag line. ABF welding personnel Wai Kitlai (#2953) continued using the carbon arc process and then proceeded grinding with a radius bur. This QA Inspector observed as QC Inspector Fred Von Hoff performed a visual and MT inspection of the excavation and then informed this QA Inspector he had accepted both the inspections. This QA Inspector performed a visual verification and observed the excavation appeared to be clear of any defects and approximately 115 mm long, 25 mm side and 23 mm deep (greater than 65% of the base metal). This QA Inspector was informed by Lead QA Inspector Bonifacio Daquinag Jr. that work would be stopped at this time and a request to proceed with the repair would be submitted for Engineering approval. The excavation work appeared to comply with ABF-WPS-D15-1004 Repair.
